Mill/Milk Water Viaduct Bat Dusk Emergence Survey and Otter Survey – extracts. Dated 16th May 2017

Page 3 of 24 - Introduction

3.3. Dusk Emergence Bat Survey Results, 4th May 2017.

3.4. Dusk Emergence Bat Survey Results, 15th May 2017.

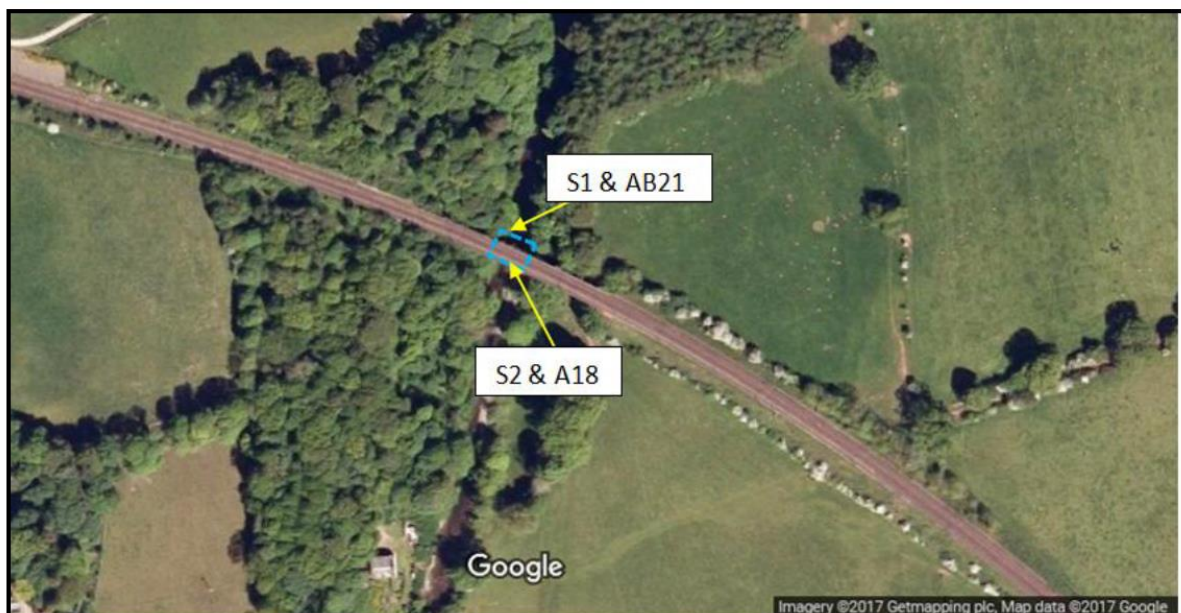
3.3.3. The position of the surveyors and Anabat bat detectors during the survey is shown below. S=Surveyor and A=Anabat. Please note the blue box shows the surveyed section of the western side of the viaduct.

3.3.1. A dusk emergence bat survey of the western half of the viaduct, including the three western arches and piers was carried out by two surveyors. Each surveyor was equipped with a Batbox Duet bat detector and a two-way radio for communication. An additional two standalone Anabat bat detectors were also used on the site.

3.3.6. No bats were seen to emerge from the viaduct during this survey. The identified bats were seen foraging between the 1st and 2nd western arches and above the western side of the watercourse.

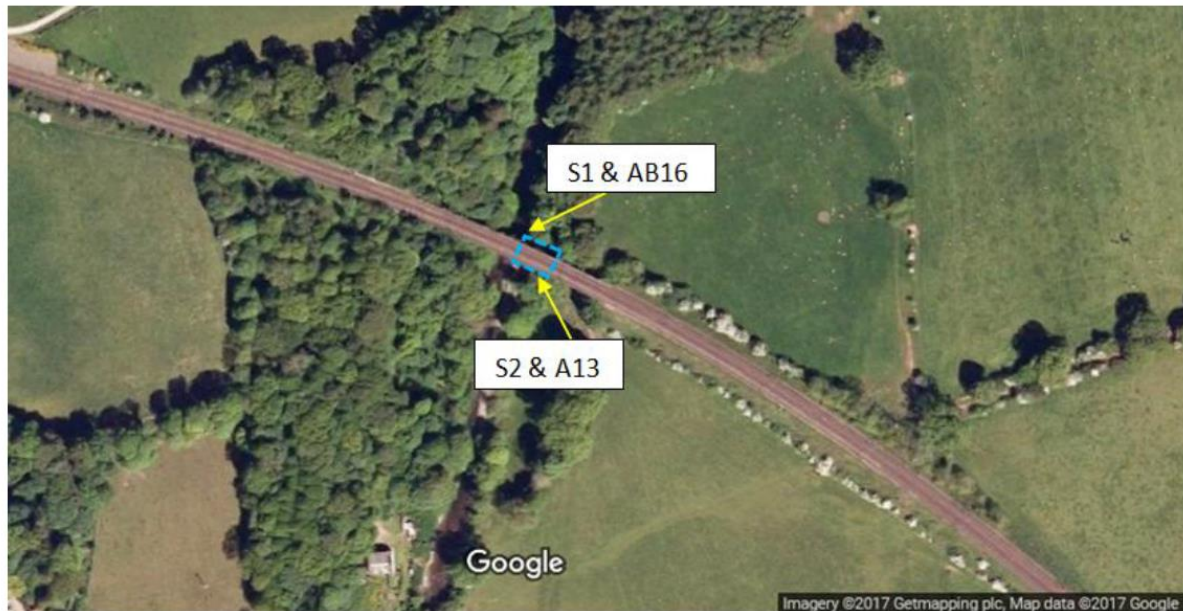
3.4.1. A dusk emergence bat survey of the eastern half of the viaduct, including the three eastern arches and piers was carried out by two surveyors. Each surveyor was equipped with a Batbox Duet bat detector and a two-way radio for communication. An additional two standalone Anabat bat detectors were also used on the site.

3.4.3. The position of the surveyors and Anabat bat detectors during the survey is shown below. S=Surveyor and A=Anabat. Please note the blue box shows the surveyed section of the eastern side of the viaduct.

3.4.6. No bats were seen to emerge from the viaduct during this survey. The identified bats were seen foraging between the 1st and 2nd eastern arches and above the eastern side of the watercourse.
